TRACKING DOWN THE MOISTURE —

HOW INFRARED INVESTIG

DIAGNOSTIC INSPECTION CAN SAVE MONEY

BY DOUGLAS C. TAIT

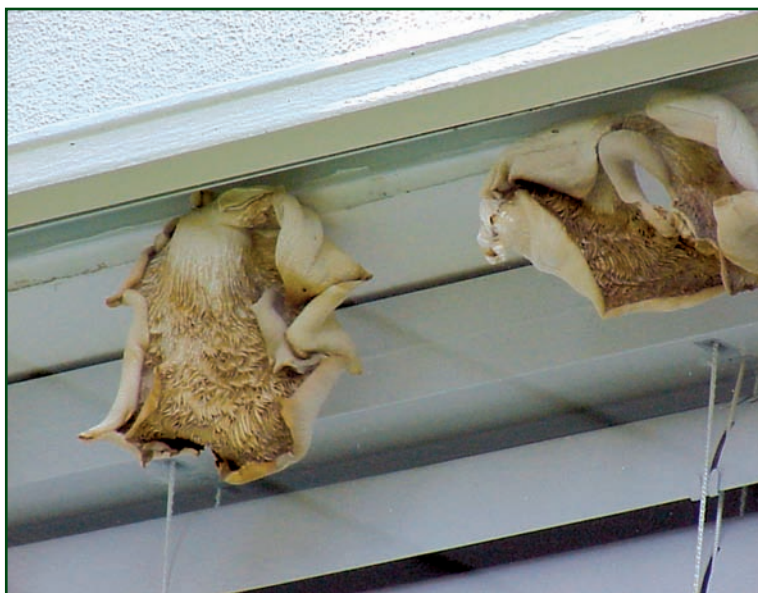
Photo 1: Previously undetected moisture is revealed through mushroom growth in a homeowner’s window.

Photo 1 is an example of undetected moisture entering a building structure. This shows mushrooms – not in a salad, but in a homeowner's window.

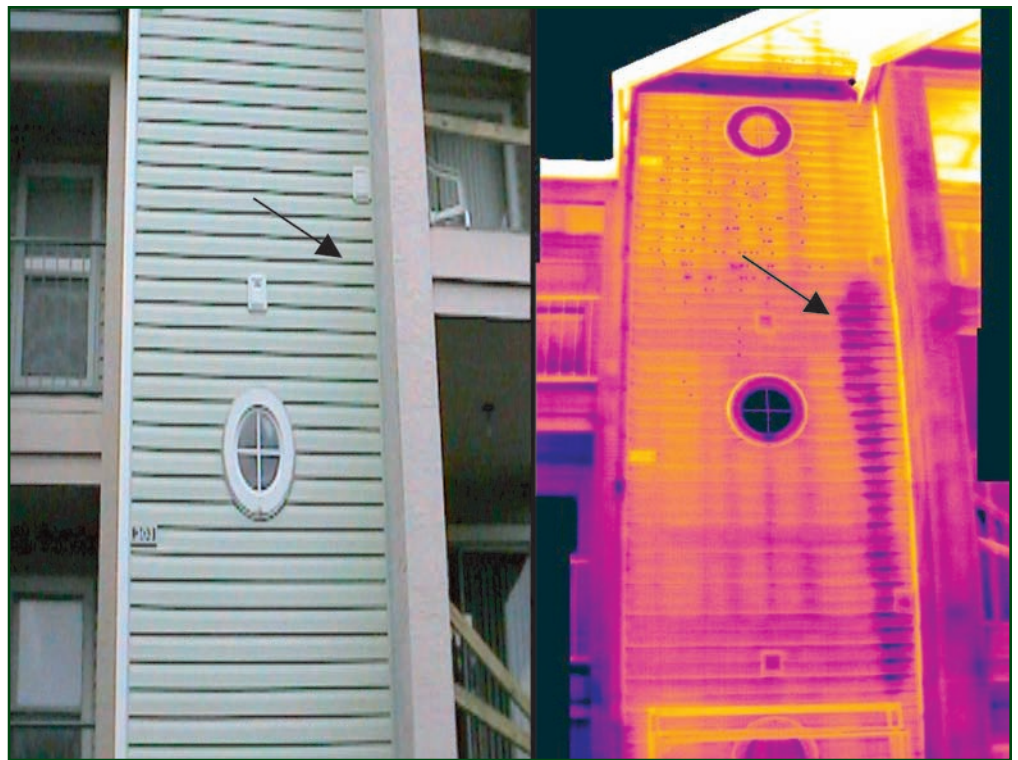
Photo 2 (left) shows apparently well-constructed exterior wall. Photo 3 (right), using an infrared camera, shows moisture infiltration not detected by the naked eye.

Photos 2 and *3* are examples of an infrared inspection after the apartment resident complained about mold and mildew appearing on the interior walls. The photo on the left shows an exterior wall that appears to be well constructed. The same photo on the right, using the infrared camera, shows the moisture infiltration, which could not be detected by the naked eye. Without removing the exterior siding, it was determined that the dryer vent installation was allowing the moisture to enter this building.
